Cause Analysis of Turbine Shaft Ultrasonic Flaw Detection Disqualification

Abstract: Heavy forging is a kind of large or deformed-size forge, used on marine, roller or power station roter. etc, which are fabricated by free forging or hydraulic compressor. The turbine shaft products, steel grade ASTM668E, rejected during ultrasonic inspection. Aiming at the problem of ultrasonic flaw detection disqualification, through Positioning saw cutting, the macroscopic test, SEM and Micrographic examination are taken out. The main cause of the disqualification were found out. The results show that, because of the exist of unbalance crystallization, highly grade general loosen happened in the cycle area, which cause the energy of ultrasonic are weakened a lot, then lead to the central quality of the forging cannot be detected clearly. What's more, the manganese sulfide precipitated at the grain boundary because of the selective crystallization occurs in the central of the ingot. The tensile stress on the interface between steel and inclusion separate the steel, caused the cracks which couldn't be welded as the plastic deformation happened in forging press, then cause the cracks. Reduce the mo

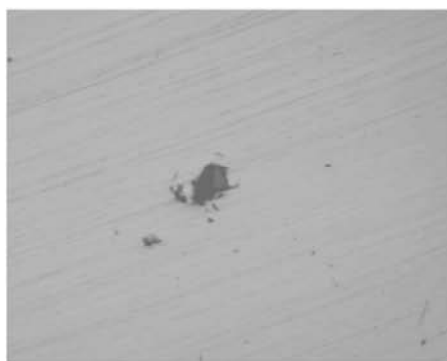
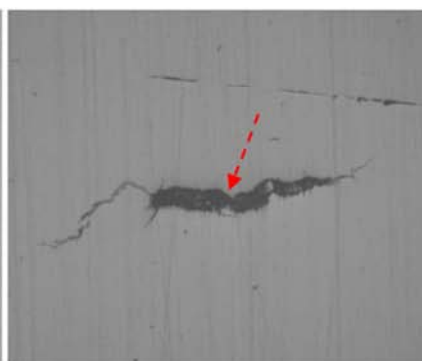
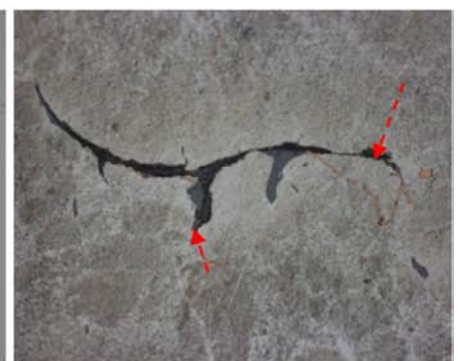
Figure 4. The microscopy analyse, 100×.

(1) Micro hole morphology

(2) Stress crack morphology

(3) The non-metallic inclusion in crack

Metallographic sample made from position A in figure 1, and the stress crack, the non-metallic inclusion in the crack of position B seen figure 4 (4% natal).

During the transverse metallographic examination of the defect, light gray inclusion attach on the interface of the micro holes and cracks, the titanium nitride, which represent golden color found too, and obviously stress cracks appears either (figure 4).

As the plastic deformation happened in forging press, the internal defects of ingot can be welded in specific grade. The generation of cracks has three forms: the micro holes occurs and growth beside inclusions; the inclusion stripping, and the cracks expansion on interface; the cracks occurs at the grain boundary, then expansions. Because the thermal expansion coefficient of Manganese sulfide is greater than steel, so its' shrinking faster, and gap happened in 1.1 percent when the steel freezing. The tensile stress on the interface between steel and inclusion separate the steel, caused the cracks which couldn't be welded [14]. The highly deformed inclusions cause metal lateral displacement, which can produce tensile stress in the metal above and below the inclusions, resulting in tension cracks in the metal, and cavitation under the action of very small stress [15], figure 4 above proved this.
